## Case Studies: **Picote Dual Color Epoxy Coating**

ASTM and NSF Certified (meets the requirements of NSF/ANSI 61-5).

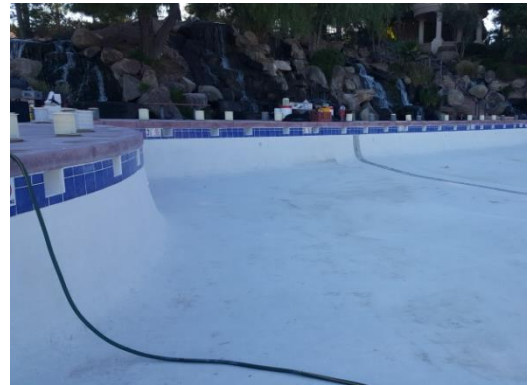
Coated 1 1/4" swimming pool line with three coats, including pool skimmers and discharge lines. Sealed leaking skimmers that were badly cracked. Contractor was able to avoid breaking up pool deck at each skimmer for replacement.

**Benefit:** Epoxy suitable for heavily chlorinated water.

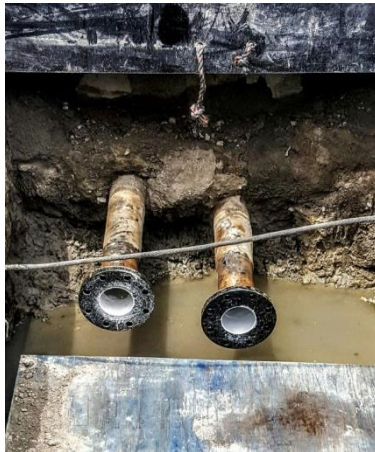
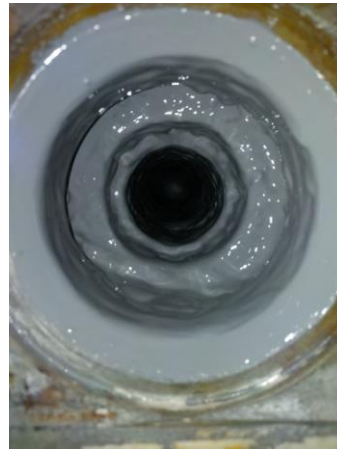
A large campus for a major insurance company was experiencing reduced flow in their 8" fire suppression main due to heavy tuberculation build up in the pipe. After cleaning the owners wanted to seal the pipe to prevent this problem in the future. High pressure and flow requirements along with 90 degree bends made CIPP repairs impossible.

**Benefit:** Sealed off heavily corroded main and was able to navigate multiple bends.
